# Instantaneous Torque as a Predictive Maintenance Tool for Variable Frequency Drives and Line Operated Motors

This paper presents three case studies on how plant maintenance and operation benefit from monitoring plant operation with modern instrumentation, particularly with instantaneous torque monitoring capabilities. The first case presented is of a medium-voltage 500 horsepower pulverizing machine motor. The second application is of a medium-voltage motor that drives a circulating 1,250 horsepower water pump (this pump was fixed right before a pump running in parallel broke in operation, which reduced output to the plant over a five-week period; an economic evaluation of this case in particular will be presented). The third and last case study is an example of how a motor coupled with a variable-frequency drive (VFD) was monitored, and how its operation was corrected using instantaneous torque signature analysis.

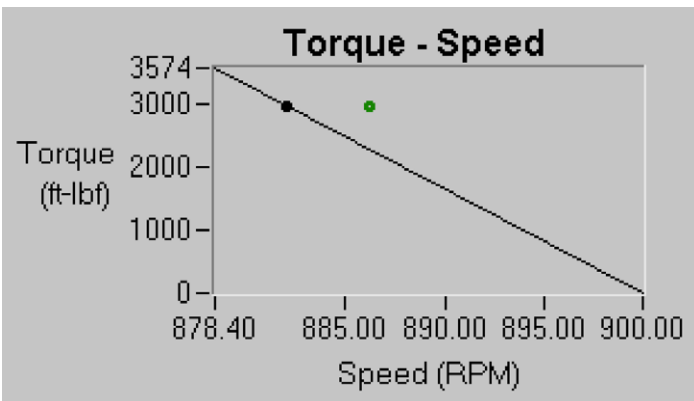
**Figure 2 – Slip line and operating point**

The motor monitored revealed a much lower slip than the nameplate slipline, as shown in Figure 2. The black line is the slip line. It runs from the synchronous point to the lower right, 900 rpm and 0 nm to the rated point, which is shown by the black point. The operational point (green dot) is to the right of the line. This shows that the motor is operating under a clearly higher speed than the nameplate would lead

one to expect.

The load of 100.3 percent, however, is far superior to this forecast. If the load forecast had focused on the slip with respect to the nameplate, the result would have been 76.7 percent. This is the result of the division of actual operating slip by rated slip.

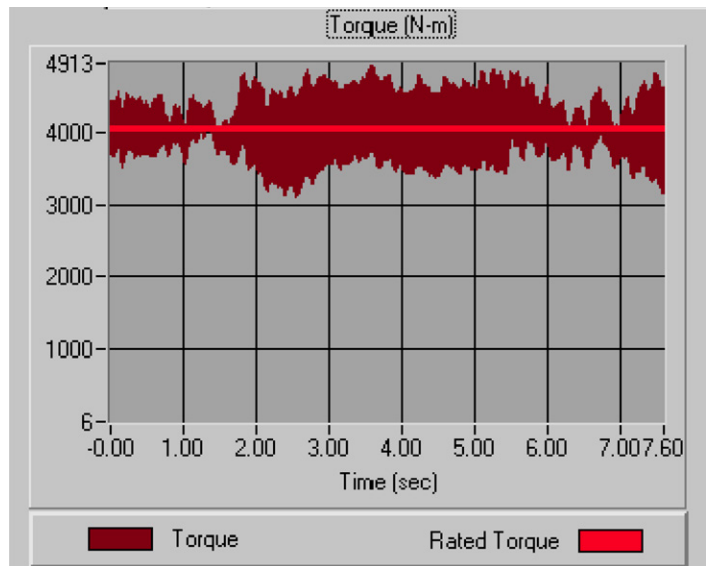
**Figure 3 – Instantaneous torque**

The rated torque is calculated for nameplate speed and hp. The brown trace shows the level of the actual instantaneous torque as calculated according to [5]. It is clear the average torque coincides with the rated torque; this is to be expected with the load at 100.3 percent. The amount of torque ripple added to that steady state torque, however, causes the motor to periodically operate at over-torque conditions (higher than 115 percent rated torque). The interpretation of this torque signature is simple: the motor under test is operating above rated load for significant periods of time. This is a typical marginal application that stresses the motor during operation. A reduction of the amount of coal fed into the pulverizing machine will reduce the motor load back to a healthy operational level.

The application investigated here specifically involved a motor for a coal pulverizing machine. This application is notorious for abrupt changes in torque, which change depending upon the sizes of coal pieces fed into it. Figure 3 shows the instantaneous torque against the motor’s rated torque.

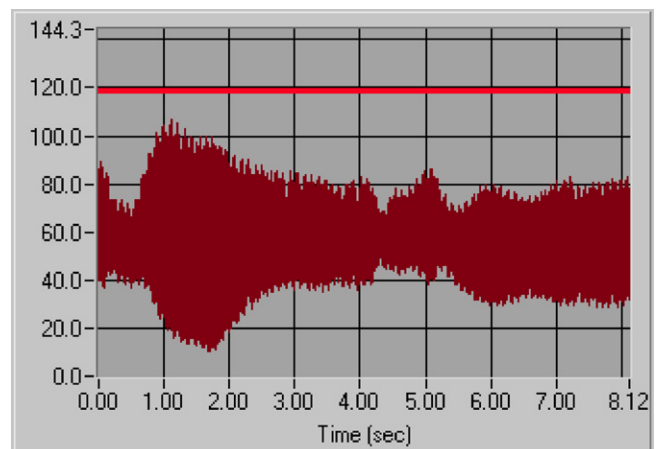
Figure 5 – Instantaneous torque of pump in question

The torque signature of the pump under question (Figure 5) differs considerably from the previous example. One main difference was that the steady-state torque was about 75 percent of the other two healthy identical applications. Secondly, the torque ripple of this application does not look like a healthy torque ripple for a large-sized pump. The torque band is too wide and does not have a steady envelope. These two differences are highly uncharacteristic of this type of application.

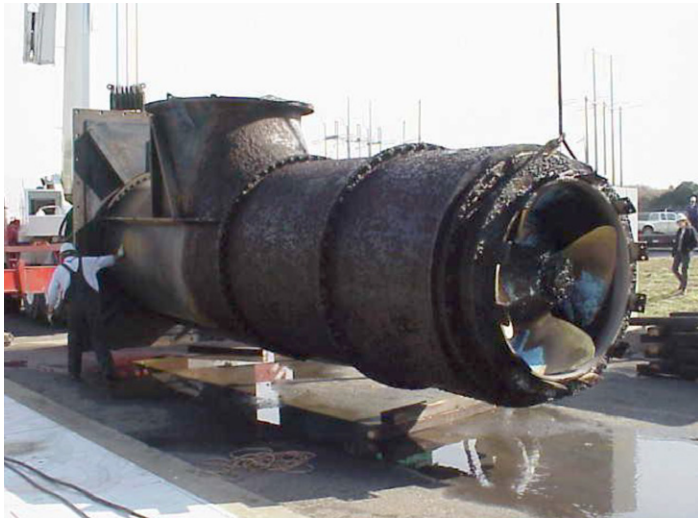
Figure 6 – Pump

Since torque is requested by the load, and the motor has to deliver the torque that the load is requesting, it was possible to state without the previous doubts that this pump had clear and severe problems. Up to this point it was not clear beyond a doubt that the load, and not the motor, was creating the different readings. This information was necessary to make the decision to stop the motor so that a diver could be sent down to examine the submerged pump. Upon visual inspection, the diver discovered the pump had lost its end bell. Figures 6 and 7 show the pump and its end bell, respectively.

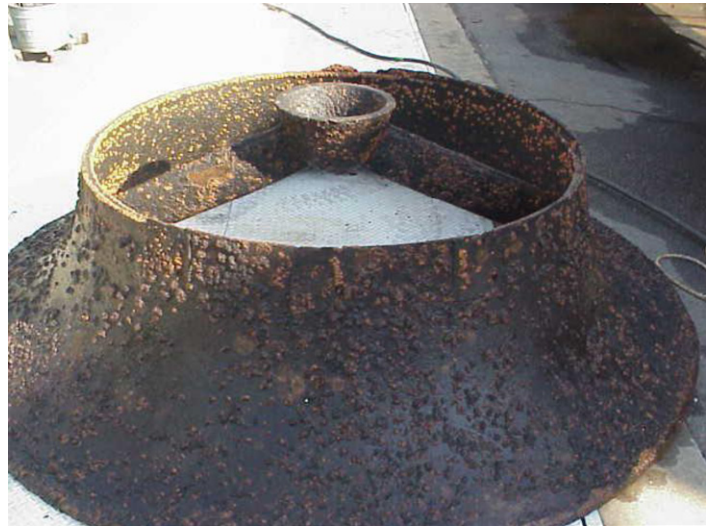
Figure 7 – Pump end bell

The function of the end bell is to act similar to a funnel and let water flow into the pump with laminar flow. Without the end bell, the impeller of the pump is in close proximity to the opening of the pump. This causes the slow-turning impeller to only partially work as a pump. It effectively causes water to circulate within the pump instead of pushing the water down the pipe, which explains why the torque is so low (it takes less power to keep water circulating within the pump as it takes to actually pump the water). Additionally, when the blades are mounted closer to standing water, it creates turbulences and cavitation. This was the source of the additional torque ripple that had been found when on-line testing.

Upon discovery of the broken end bell, the pump was pulled for repair. At this point it was possible to take pictures shown in this paper of both, the pump and the end bell.

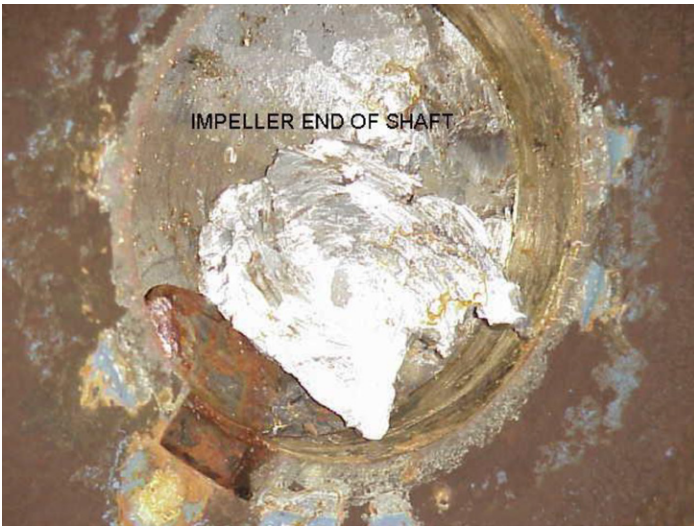
Figure 8 – Broken shaft at impeller end

One week after the pump was repaired, one of the two adjacent pumps broke a shaft, which in turn damaged the pump in the process. Figure 8 shows the broken shaft at the impeller end of the shaft. This failure had to be repaired immediately; removal of the pump from operation, repair and reconditioning work and re-installation took five weeks.

The plant maintenance personnel concluded that this failure could have been linked to the additional torque ripple of both parallel pumps created by the broken endbell of the first pump in question. Until this point, no data or argument had arisen to prove or disprove this conclusion.

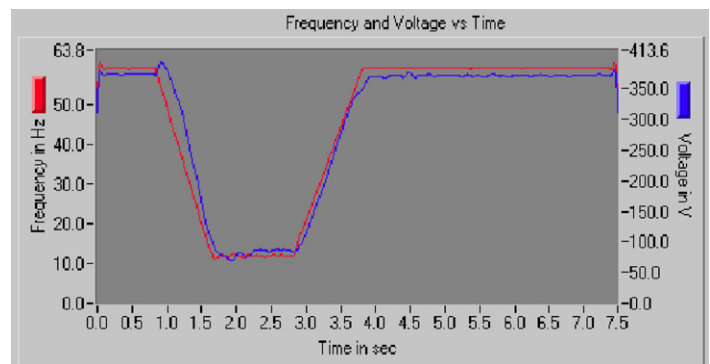
Figure 9 – VFD frequency and voltage level vs. time

Figure 9 graphically depicts the described process with torque and frequency over time. Frequency is shown in red, and voltage in blue. Data was captured over a period of 7.5 seconds. The VFD runs the motor at 60 Hz, and then it slows down to 12 Hz for cutting. In this case, the cutting of a log takes less than 1.4 seconds, and the VFD ramps the frequency back up to 60Hz.

The particular control of this VFD is of the V/f type. Voltage level is kept proportional to the operating frequency. This is a very common control type of control for low-cost implementations.

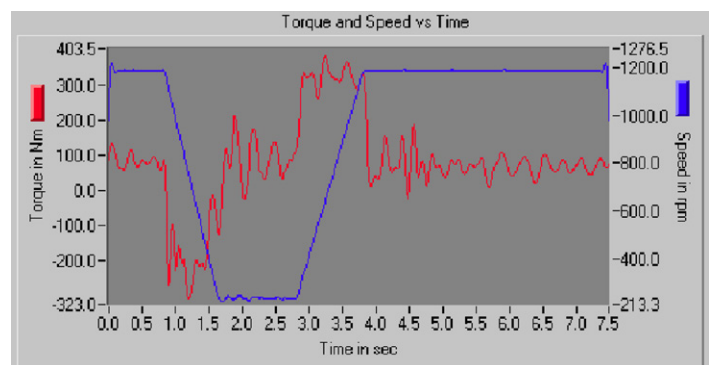
Figure 10 – Speed and torque vs. time

Figure 10 shows torque level (red) versus time, and the operational speed (blue) of the motor versus time. It reveals that the maximum speed of the motor is 1200 rpm, while the speed of the motor during the cutting of the log is of only 215 rpm. Torque level is constant when the conveyor operates at constant speed. During the time the VFD backs

the voltages down, the motor speed slows down as well in response to reduced torque. As soon as the low speed is reached, the torque level normalizes to the steady-state level. During the following acceleration process, it is necessary to increase the torque level, which falls back to the steady state once acceleration is completed.
